## MARINE INVESTIGATION REPORT

M01C0063

### PERSONS OVERBOARD

**WATER JET BOAT *SAUTE MOUTONS 14***

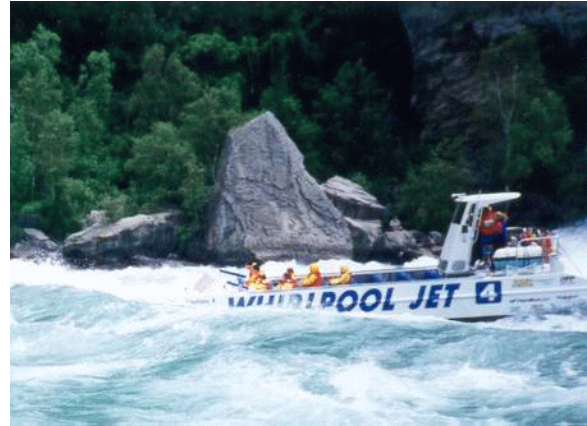
Photo 2. Proceeding into Devil's Hole

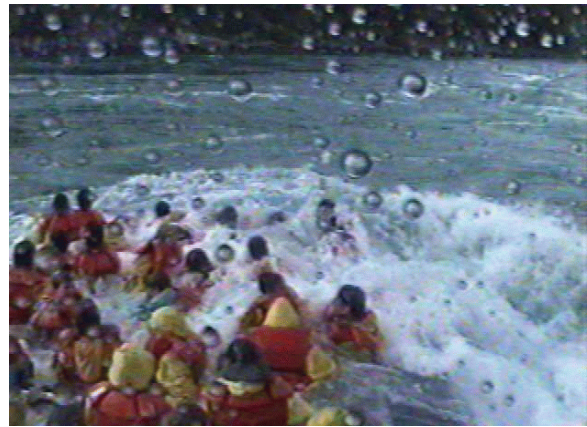
At approximately 1815, about three quarters of the distance through the rapids, the passenger area remained full with water and the vessel approached in quick succession, a large trough and subsequent wave. The vessel proceeded into the trough and wave with no let up in speed. The forward section of the vessel's windshield and the forward half of the passenger complement disappeared from view, after having passed through the wave. These passengers were completely submerged for approximately four to five seconds beyond the wave before the forward half of the vessel rose to the surface.

**Photo 3.** Forward section submerging

As the bow of the vessel was under water and rising to the surface, the outflow of water carried the outboard of the two sisters over the side. The inboard sister attempted to keep her on board but was carried or pulled overboard. At this time the operator had reduced power which slowed the vessel and at the same time noticed the second passenger going over the starboard side.

Immediately prior to the occurrence, the time between wave encounters did not allow the vessel to evacuate the water and re-acquire its normal operating draught. Thus, when the vessel bow dipped down into the next wave trough it did not rise with the next approaching wave but rather ploughed into it. The vessel continued to submerge its bow at a location beyond the wave as seen in the trip video replay. The availability of the high engine horsepower (1620 hp) applied to the water jets allowed the operator to continue to move the vessel, with the passenger compartment in a flooded condition. Power was not reduced until the forward section of the vessel had been driven underwater.

At the end of the 2001 season, Niagara Gorge Whirlpool Jet Boats Ltd. advised that the bailing ducts, which evacuate water from the passenger area, were expanded in size and re-designed. The previous design incorporated a 90 degree turn in the duct. The new design and larger construction will allow the same volume of water to be evacuated in a straight line direction aft and thus shed water faster from the passenger seating area. The weight of the water exiting in the reconstructed tubes helps to bring the bow up and drop the stern, further helping to trim the boat.
